FIGURE 1.1
Detailed LADS Bathymetric Data

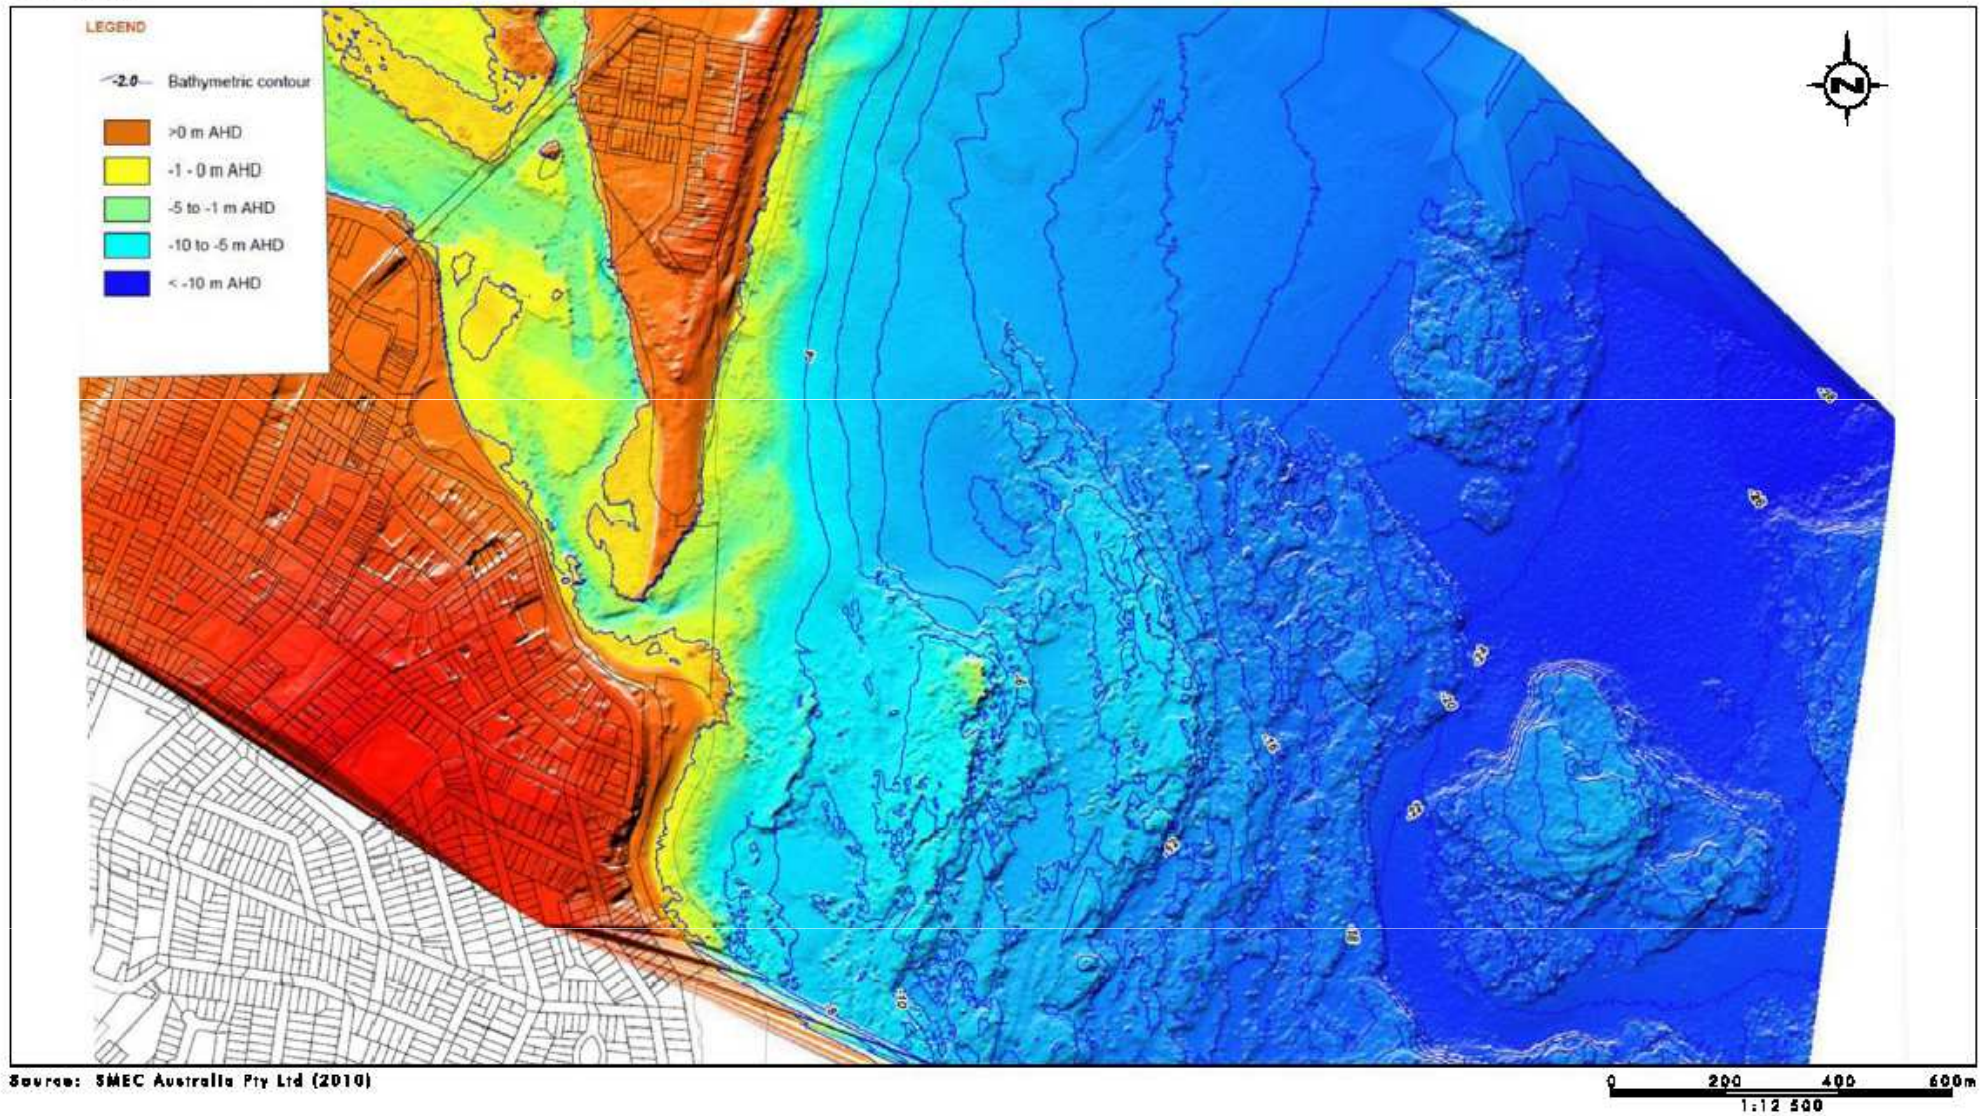
Source: SMEC Australia Pty Ltd (2010)
